Re: 2003 Excellence in Surface Mining Award Program

Castle Gate Holding Company
Castle Gate Mine
P.O. Box 30
Helper, Utah 84526-0030
C/007/004

**Hardscrabble Canyon
Castle Gate Mine
Excellence in Surface Coal Mining Reclamation Award
2003 Nomination**

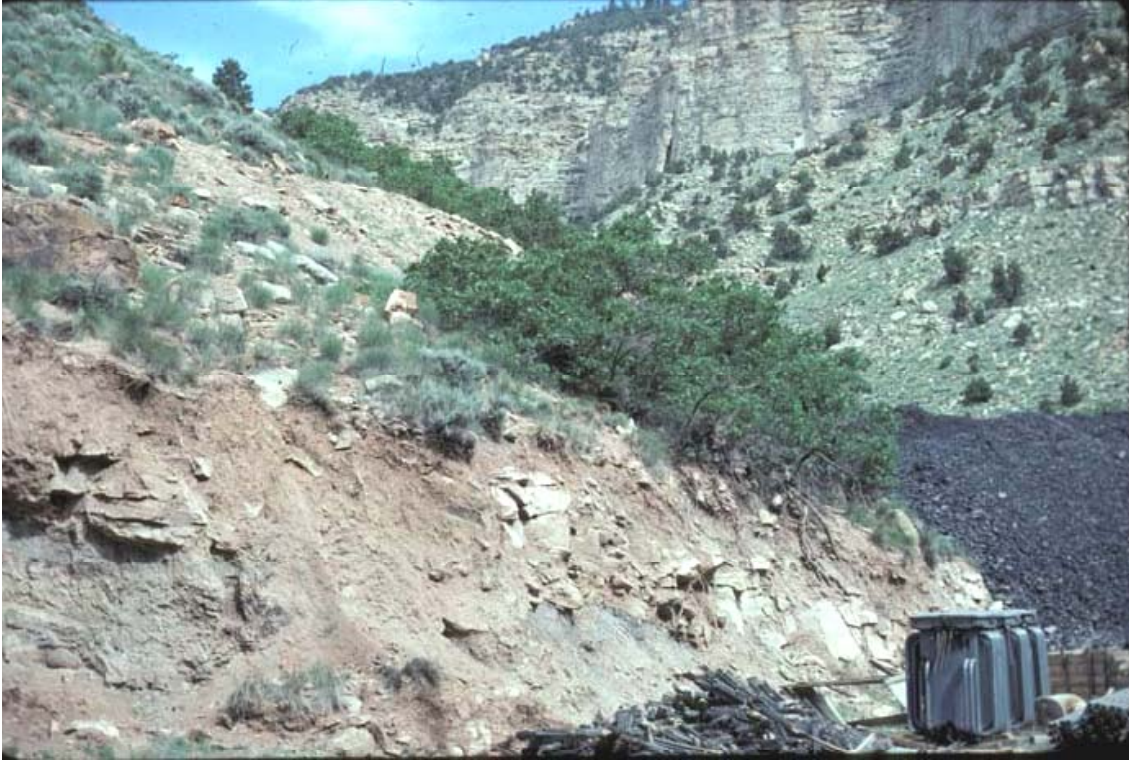
Photo 1. Goose Island refuse area prior to reclamation.

A coal preparation plant operated in Hardscrabble Canyon until 1979. Refuse from the operation was placed at the intersection of two tributaries blocking the flow path to the main ephemeral stream. This area, known as "Goose Island," was reclaimed in 1984. Although Phase I bond release was granted in 1985 the Permittee did additional regrading work in 1999 to improve the drainage. In the process of improving the drainage more soil material was spread on several problem areas.

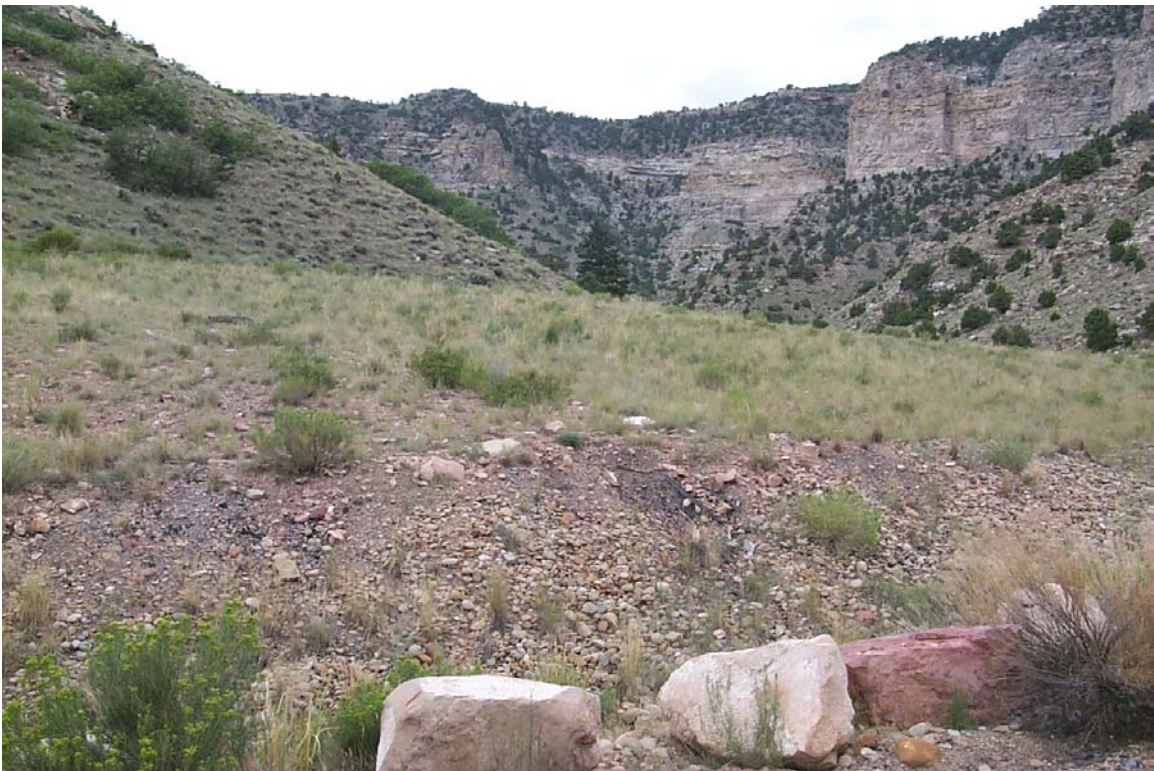
Photo 2. Goose Island refuse area after reclamation.

The Goose Island refuse area of Hardscrabble Canyon was graded and seeded in 1984 (8.79 acres) and transplants were planted in 1985. Phase I bond release was given later in 1985. Limited regrading was done in this area in 1999. Phase I bond release was approved for Hardscrabble No. 3 and No. 4 Mine areas (27.7 acres) on February 14, 2001. The substation (0.26 acres) was reclaimed in 2002 and was not included in the Phase I bond release area.

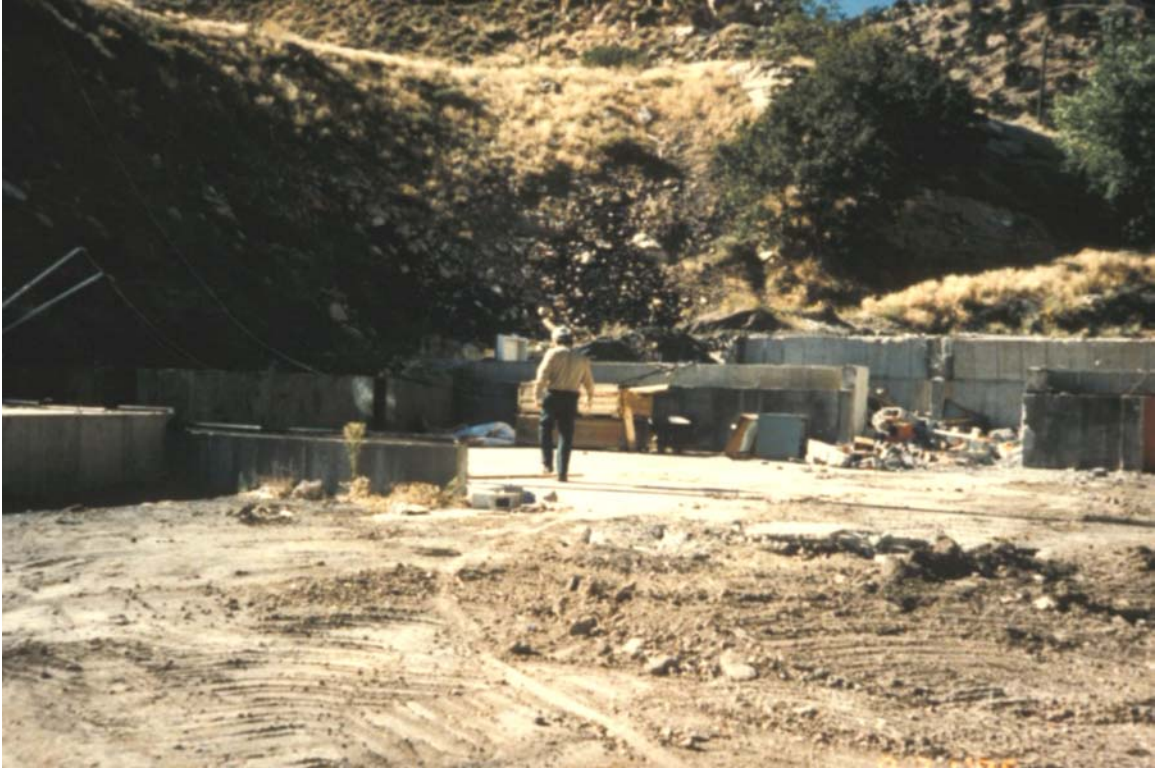
Photo 3. Coal waste was 50 feet deep in the Dog Flat side canyon.

Notably, a side canyon called "Dog Flat" had been filled up to about fifty feet deep with refuse. Dog Flat was a large flat area with a very steep drop to the main part of Hardscrabble Canyon. The area was originally reclaimed in 1987, which left the refuse in Dog Flat. But, later the Permittee decided reclamation would be much better if the

canyon was restored to a more natural configuration. About 15,000 cubic yards of refuse was removed from the canyon and graded into other parts of Hardscrabble Canyon. This exposed a natural rock outcrop that blends very well with the surrounding area. The drainage could function more naturally using bedrock grade controls to drop the channel 75 feet from Dog Flat down to the main drainage in Hardscrabble Canyon.

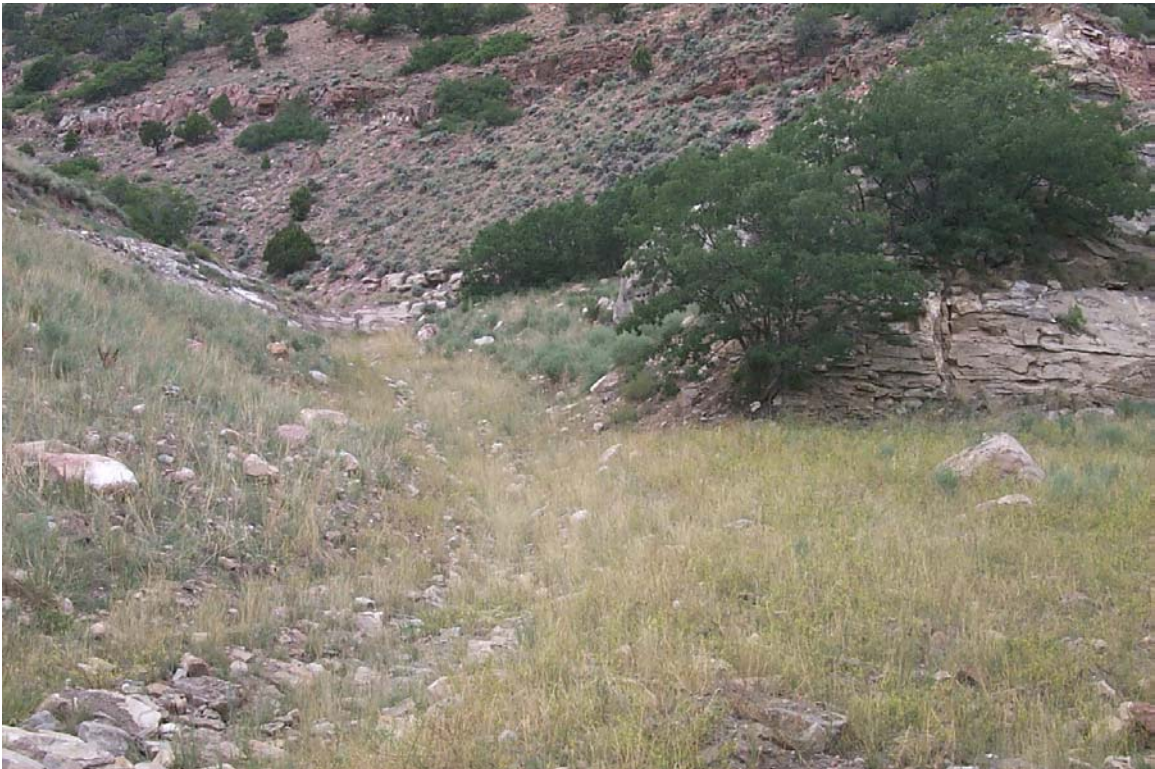
Photo 4. Coal refuse removed and ephemeral drainage restored in the Dog Flat Canyon.

The drainages in both the Hardscrabble and Dog Flat canyons use a buried channel design. This design starts with a well rip rapped over designed channel. The channel is then covered with growth material and seeded. This design closely matches ephemeral drainages in the undisturbed area.

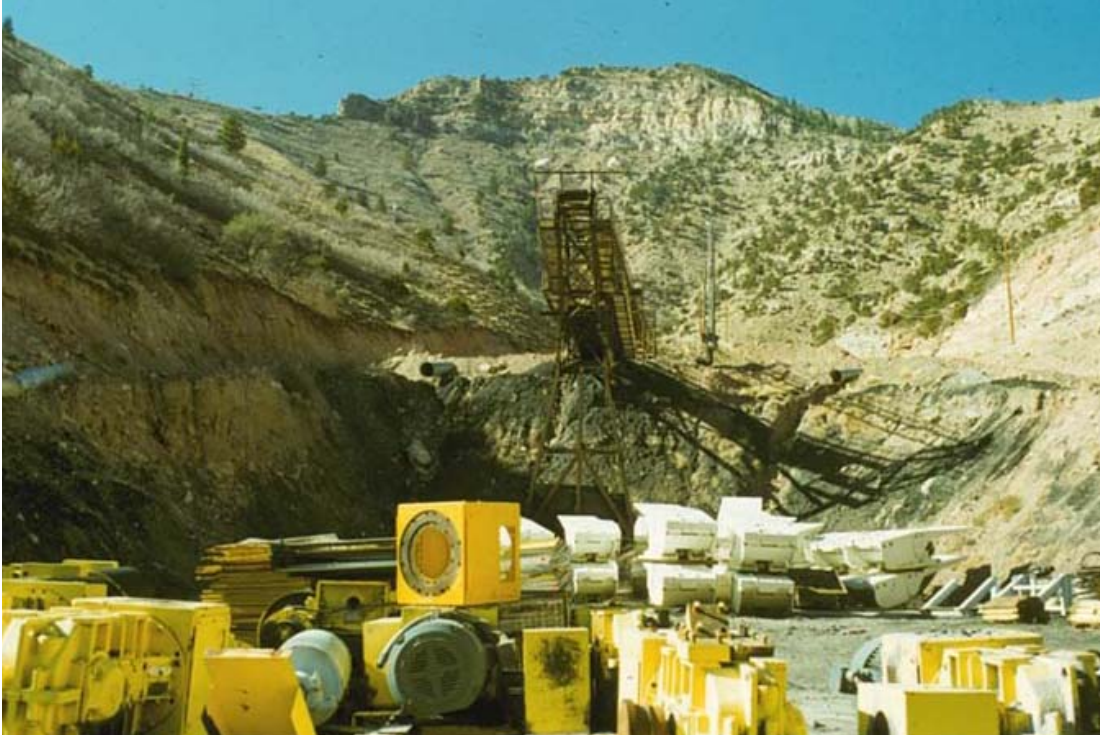
Photo 5. This belt line is from the No. 4 Mine.

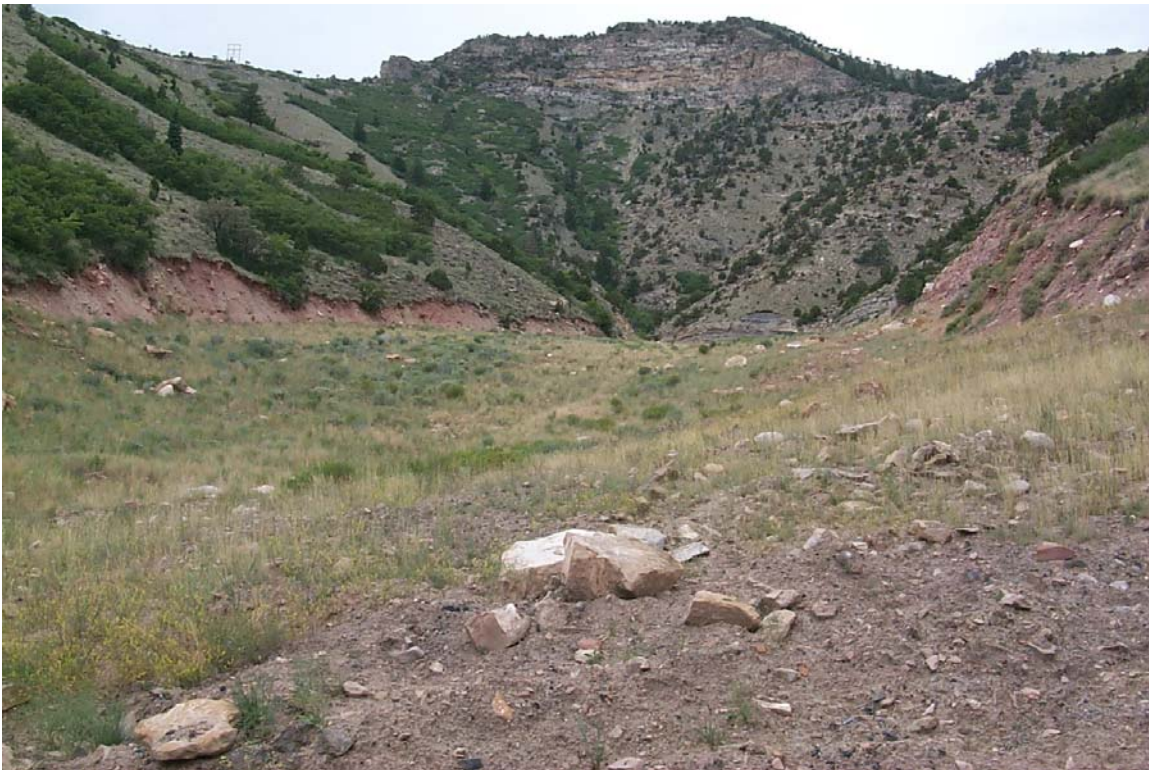
Photo 6. The No. 4 Mine canyon was reclaimed before the Permittee revised the reclamation plan; some areas in the canyon were reworked.

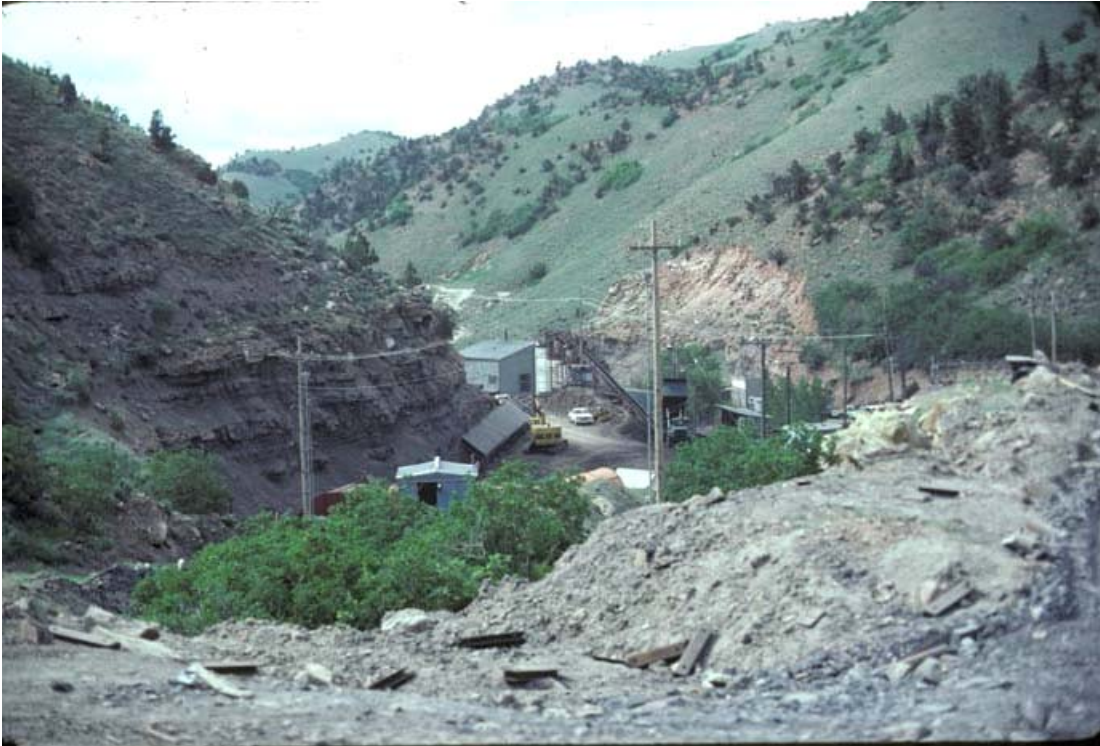
Photo 7. This photo was taken up canyon from the No. 3 Mine prior to reclamation.

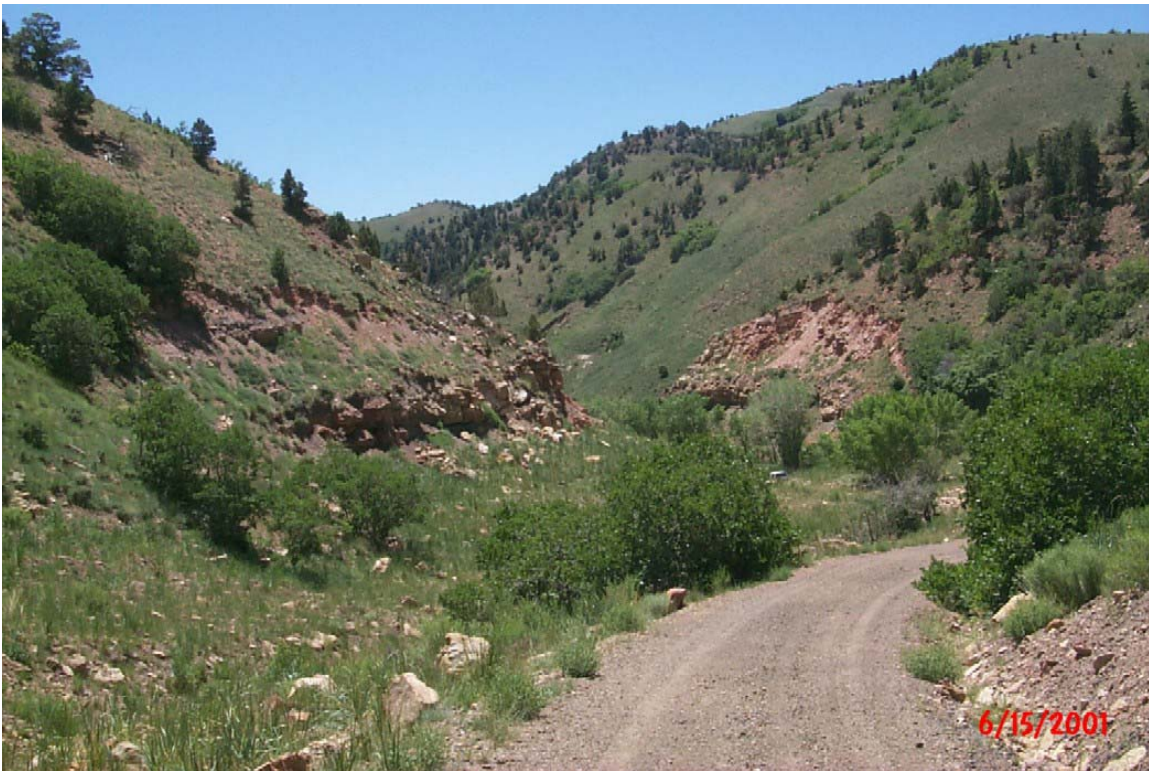
Photo 8. This photo was taken up canyon from the No. 3 Mine after reclamation.

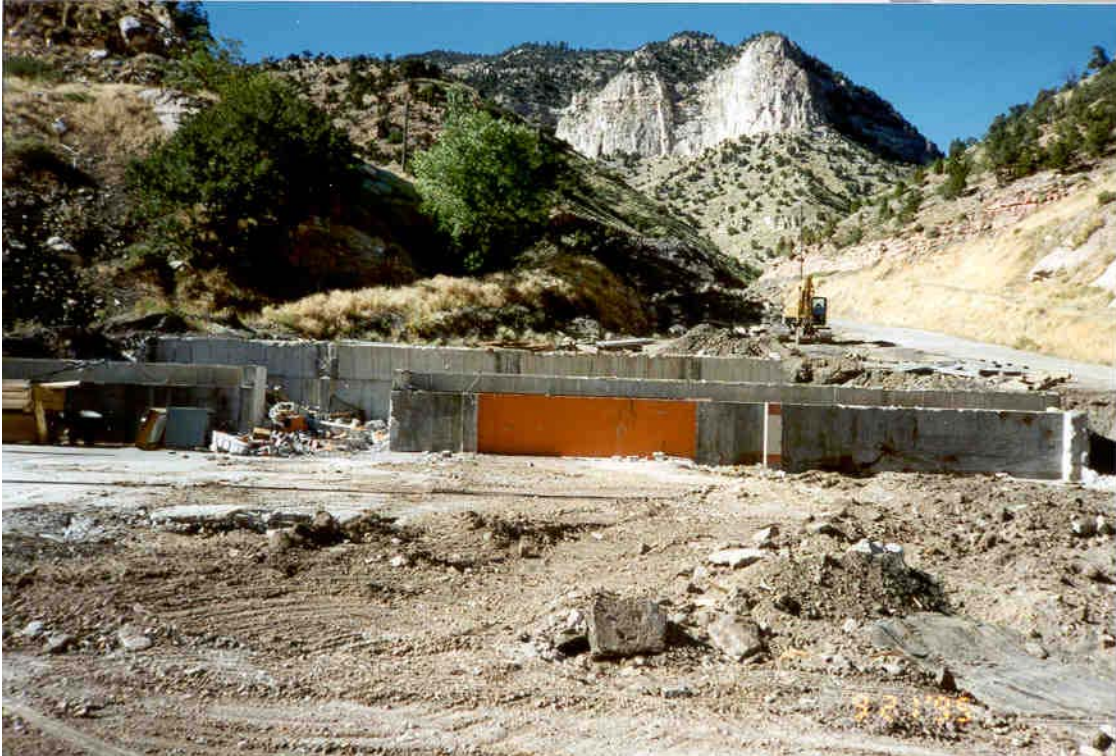
Photo 9. The facilities area photo was taken during demolition. The main channel was reestablished and the road realigned for the postmining land use.

Utah regulations require the operator to establish a channel capable of conveying the runoff from a 100-year, 6-hour precipitation event. Instead, in the main drainage of Hardscrabble Canyon the Permittee built a channel capable of carrying the flow from a 100-year, 24-hour storm at an additional cost of about \$26,000 (1998 dollars). The Permittee feels the long-term benefits outweigh the additional costs. In addition, the channel was extended farther up the canyon than required in the original designs. This was done to better link two sections of the channel but resulted in having to move a few extra thousand cubic yards of coal waste. The operator was able to preserve several fully grown cottonwoods and oaks by realigning the channel from the position originally proposed.

The pre- and postmining land uses are wildlife habitat and grazing. The main access road in Hardscrabble Canyon was regraded and then reestablished as a 10 to 12 foot wide dirt road for the postmining land use. A local rancher uses the road to trail his livestock to the top of the plateau where he leases grazing rights. The mining and reclamation plan contains information and letters documenting this ownership and use.

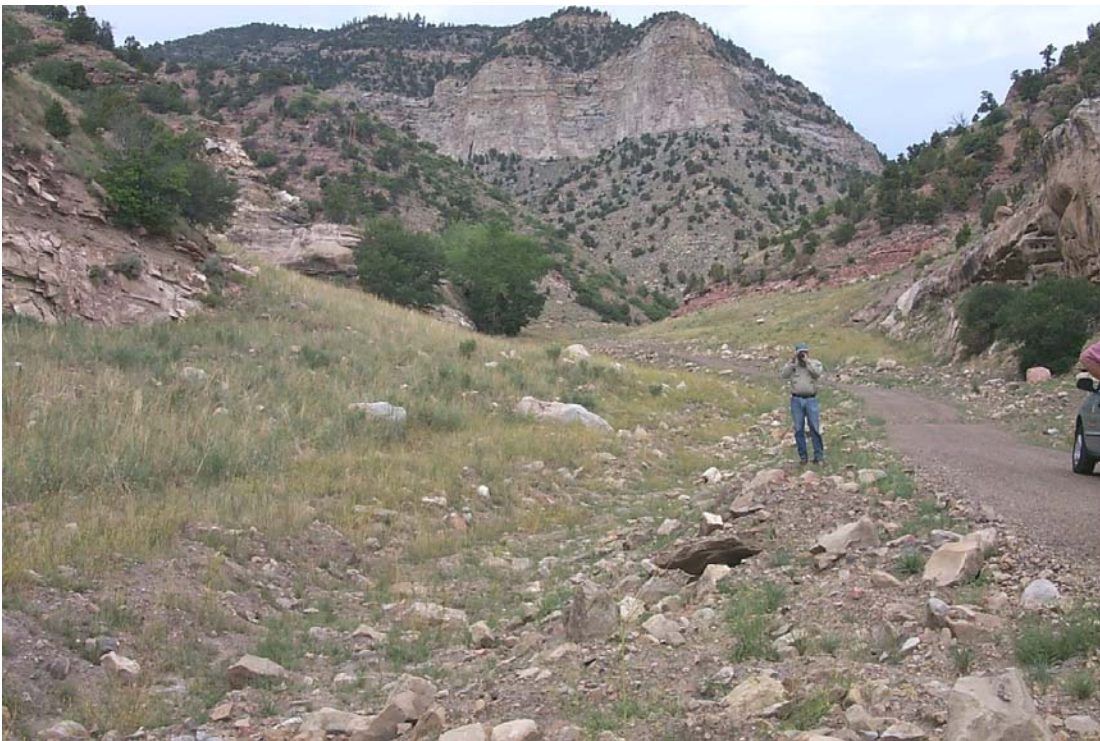
Photo 10. The ephemeral channel was reestablished using the "buried channel" concept.

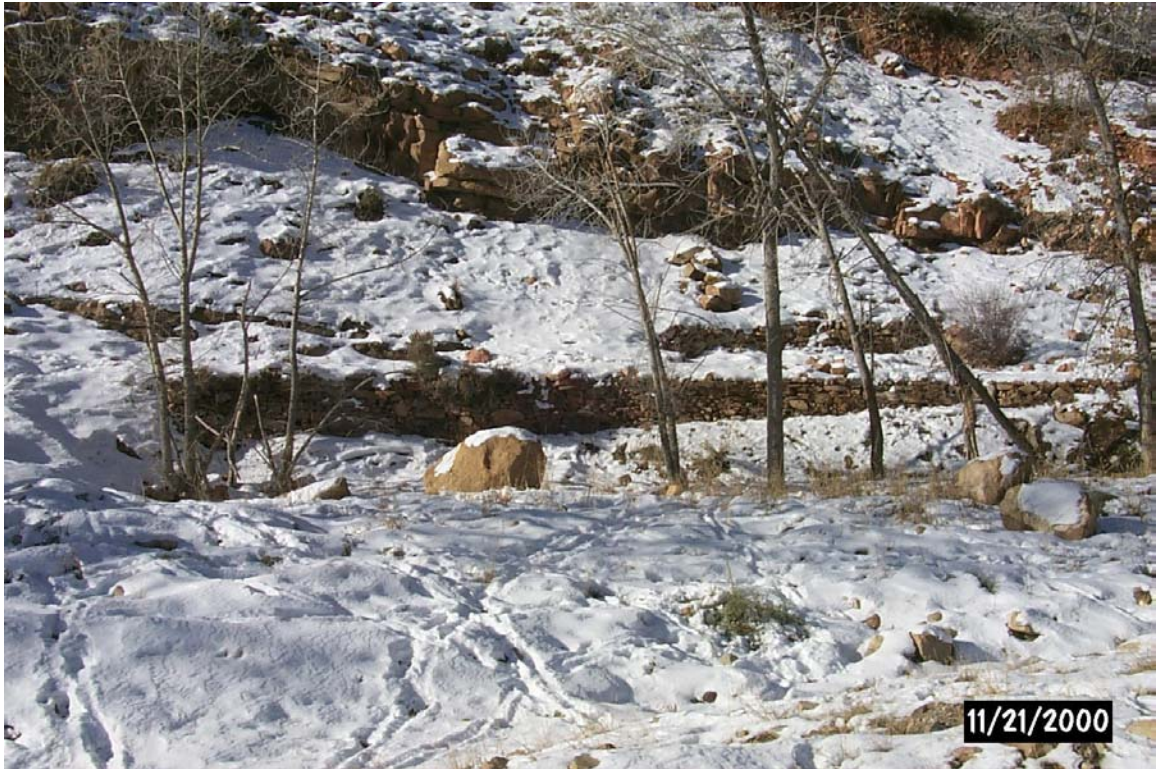
Photo 11. Italian rock wall masonry was retained in the area to remind us of the mining heritage.

A 75 foot section of Italian rock wall masonry was retained in the area of the upper bath house. The masonry is similar to other rock walls found in Carbon County that were constructed around the turn of the 20th century by Italian craftsmen. The rock wall is considered an enhancement to the postmining land use, since the people of Carbon County are very proud of their mining heritage and do not want all traces of coal mining remove from these sites. The remaining masonry will serve to remind those who pass through Hardscrabble Canyon of that heritage.

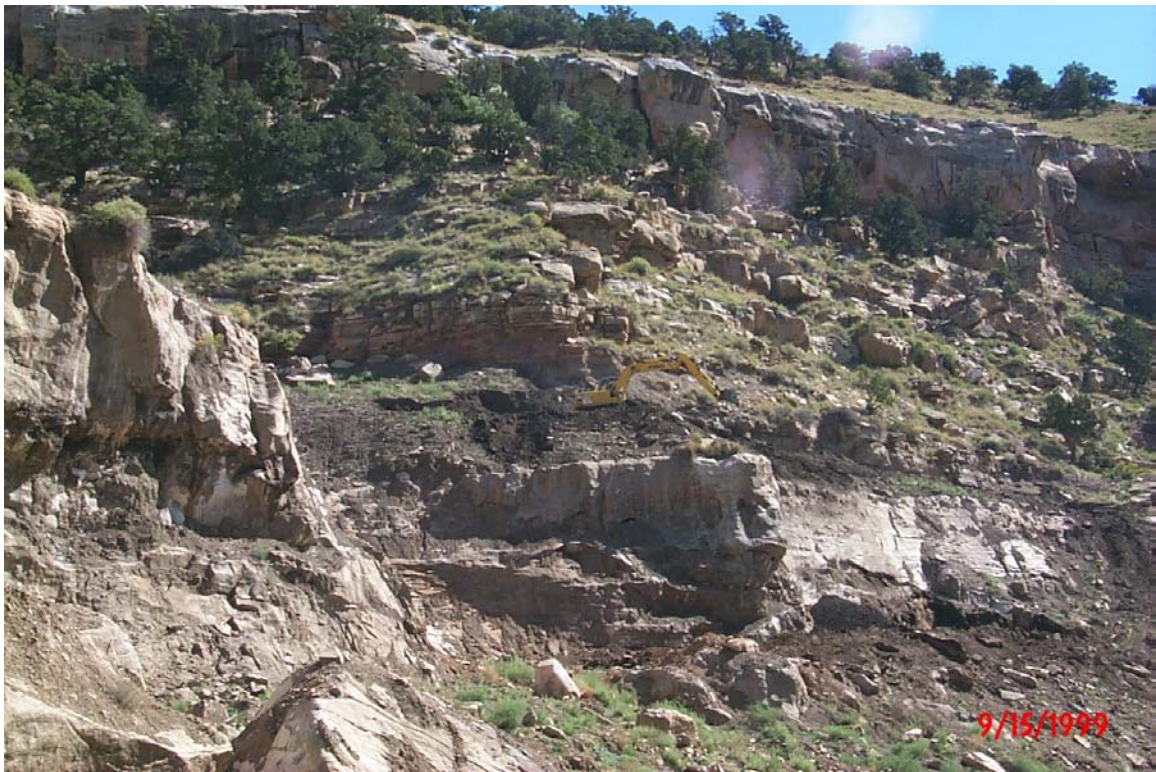
Photo 12. Retained cut slopes blend well into the natural rock cliffs in the area.

Because the site was disturbed before 1977, there was no consideration for how highwalls and cut slopes were to be reclaimed. It was impossible to completely backfill all highwalls and cut slopes, Castle Gate Holding Company and the contractor did remarkable work to make the remaining cuts and highwalls look natural and blend into the existing landscape. All available material on-site was used to backfill the highwall and cut slopes to a concave slope configuration. Coal debris, coal refuse and any acid- and/or toxic-forming material exposed or excavated during reclamation grading were removed and used as backfill against the highwall, cut slopes, and excavated trenches. This material was then covered with four feet of overburden and substitute soils. Some upper areas of the highwall and selected cut slopes remain and blend into the existing cliffs in the natural environment. Large rocks have been placed at the bottom of two of these areas, and they look like natural rock falls.

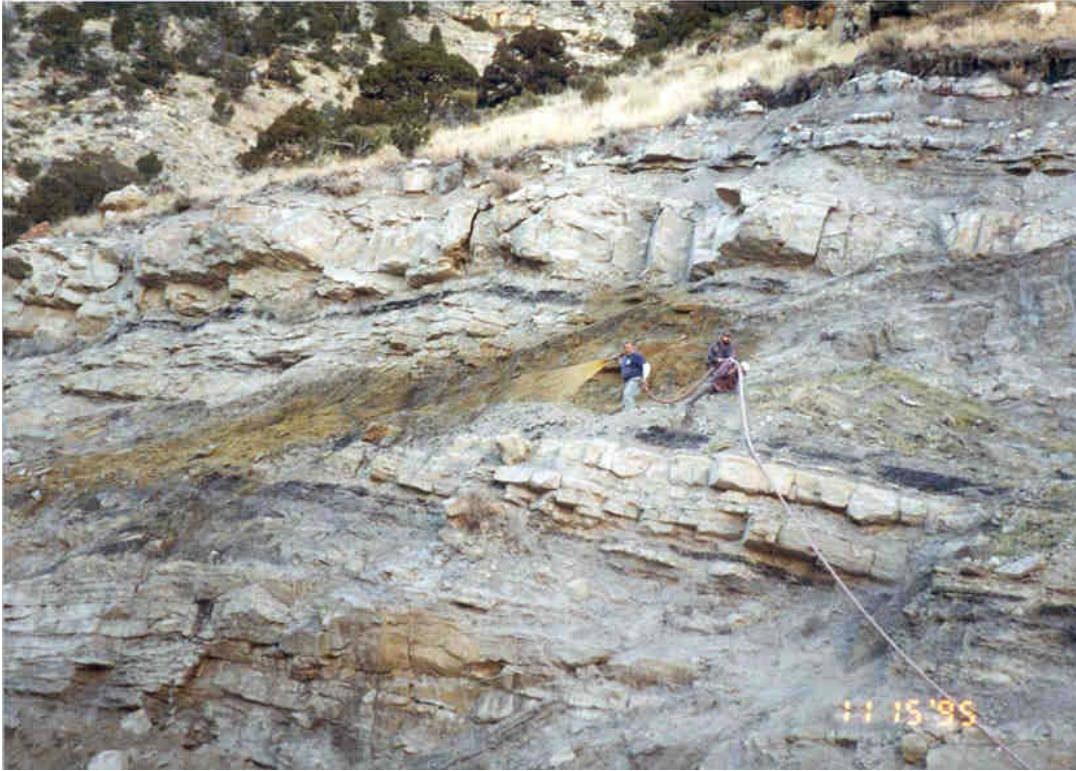
Photo 13. Hydromulching a retained cut slope in the No. 4 Mine area of Hardscrabble Canyon.

After the graded areas were gouged, the seed was applied by hand broadcasting methods. The site was then mulched with a combination of straw mulch and hydromulch to help reduce erosion. The disturbed area was planted with 5,000 tublings, 1,700 No.1 gallon and 120 No. 2 gallon containerized shrubs. The planted species were: serviceberry, chokecherry, current, Mountain mahogany, bitterbrush, Woods rose, cottonwood, snowberry, elderberry, and Rocky Mountain maple.

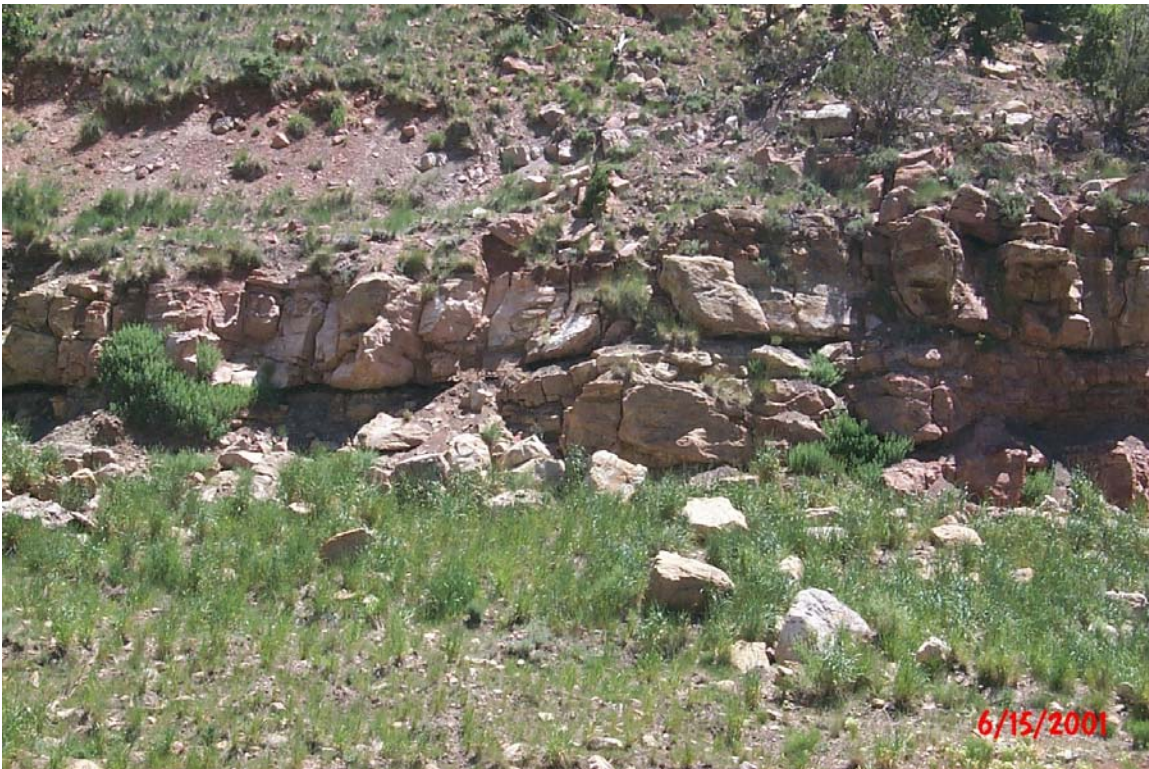
Photo 14. Large rocks were spread on the surface for visual effects and to provide flora and fauna with a microhabitat.

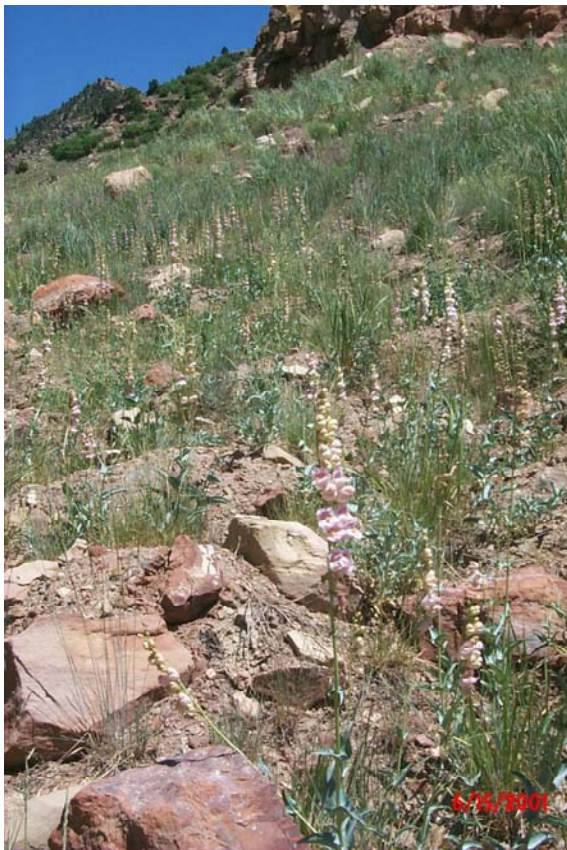
Photo 16. Although grasses dominate the vegetation cover, there is a good mix of forbs and shrubs.

The mining and reclamation plan contains baseline vegetation cover data from 1981 for two undisturbed areas in an adjacent canyon. A comparison of the (2001) cover values between the reclaimed area and these undisturbed areas show the reclaimed area has statistically more cover (44.82%) than the adjacent canyon grass-sage reference area (38.9%) and greater than 90 percent of the cover in the adjacent canyon's mixed brush reference area (47.7%). Cover from introduced species was minor; 5.19 percent and relative cover was 11.58 percent.
